BULLETIN No. 19

# SANTA ANA INVESTIGATION

## Flood Control and Conservation

By WILLIAM S. POST  
Hydraulic Engineer

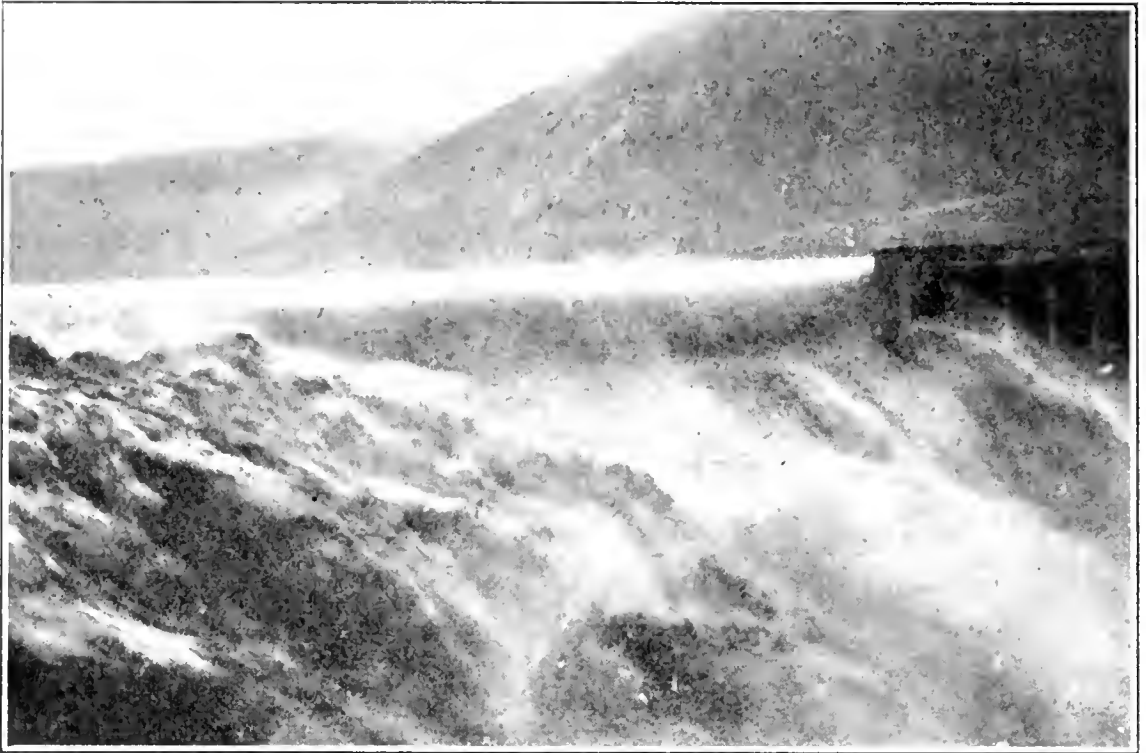
FIG. 2.—San Dieguito River near San Diego. Spillway of Lake Hodges, flood of 10,000 second-feet.

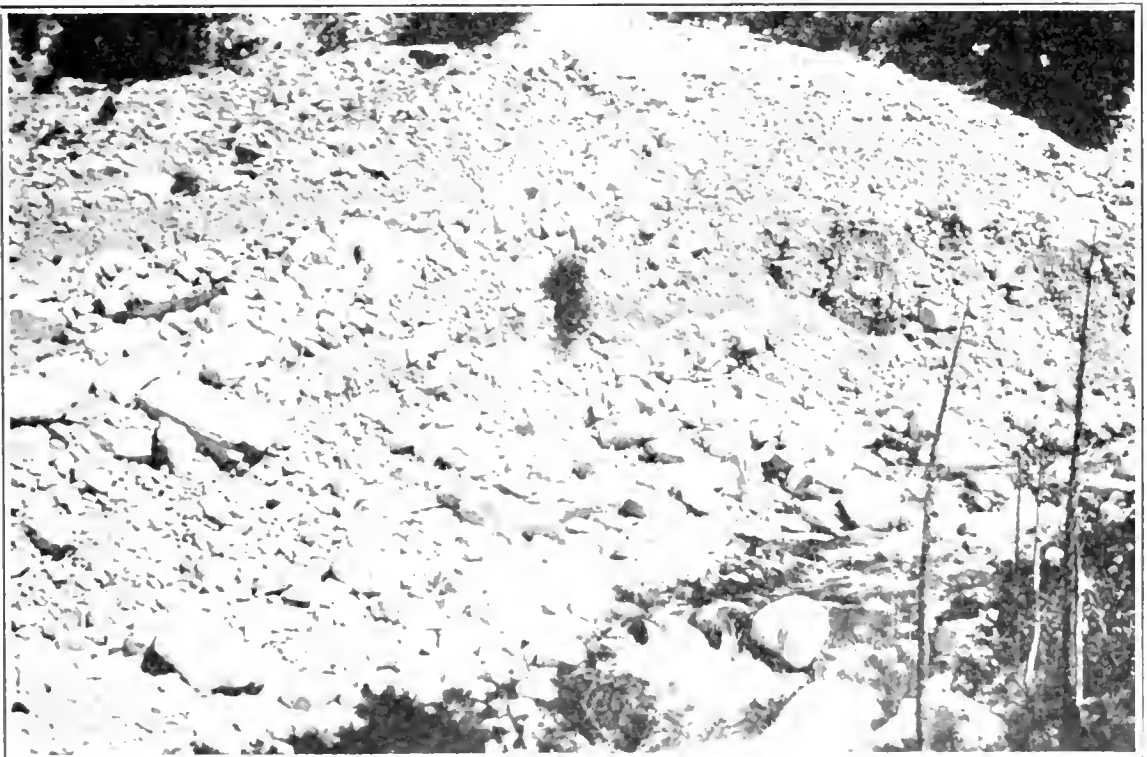
FIG. 6. Remnant of natural dam on Bear Creek at former Slide Lake, caused by debris carried by Slide Creek, a side canyon. The dam was washed out by flood of February, 1927.

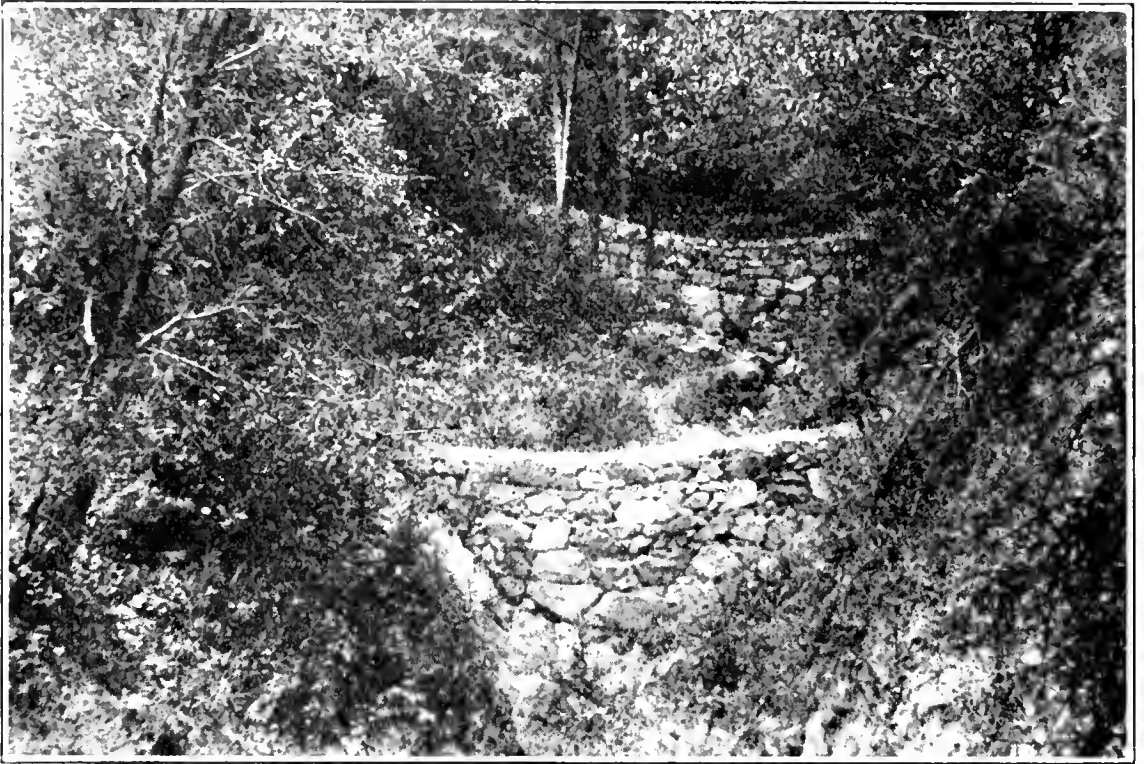
FIG. 7—Check Dams in Pickens Canyon. Third and fourth above footbridge near White place.
